MAJOR DEFECT TIMELINE

How to use this Home Buyers Guide

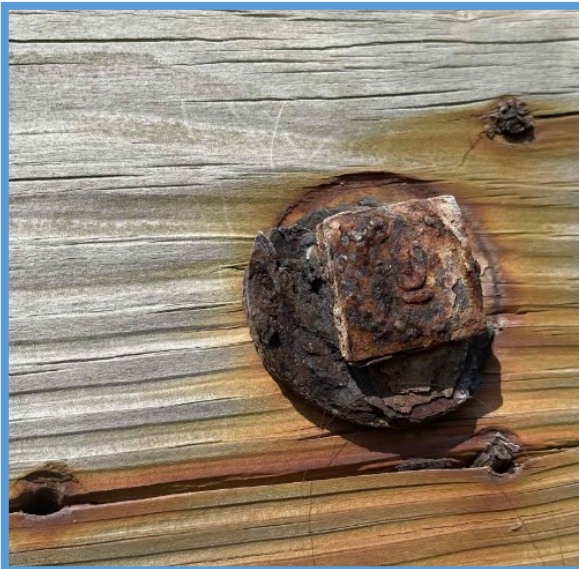
Look for rusted bolt on the ledgerboard (the plank that connect the deck to the house)

Locate the “ledgerboard”. This is the board that attaches the deck to the home. The nails and or connector brackets here may exhibit signs of rust and corrosion. If the nail heads show corrosion the nail shank will have lost its ability to resist shear forces. When a deck falls down it is usually due to shear force

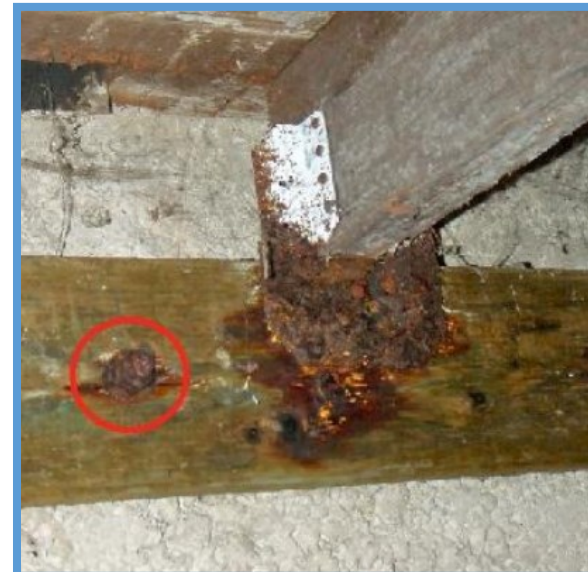
Look for rusted joist hanger and nails. The dissimilar metals iron in the steel connectors and copper in the lumber creates a galvanic reaction which causes corrosion

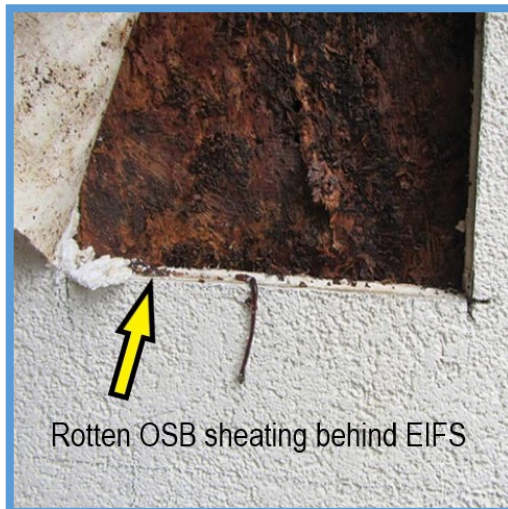
Damaged substrate

Rotten OSB sheathing behind EIFS

Look for tell tale stains where gutters abut up to the walls, open cracks and seams around windows, bulges and visible damage to the EIFS cladding. Inside the home look for water stains and damage around the interior window frames and casings. Also, water damage to the wood flooring, baseboards or carpeting. With visible damage the next step would be invasive moisture testing to confirm internal water damage.

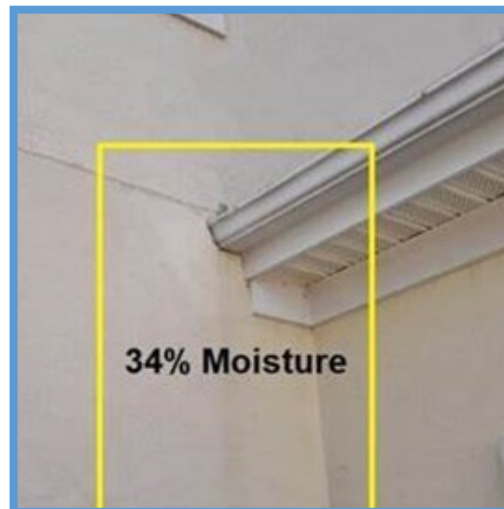
Water stains below improper gutter end

34% Moisture

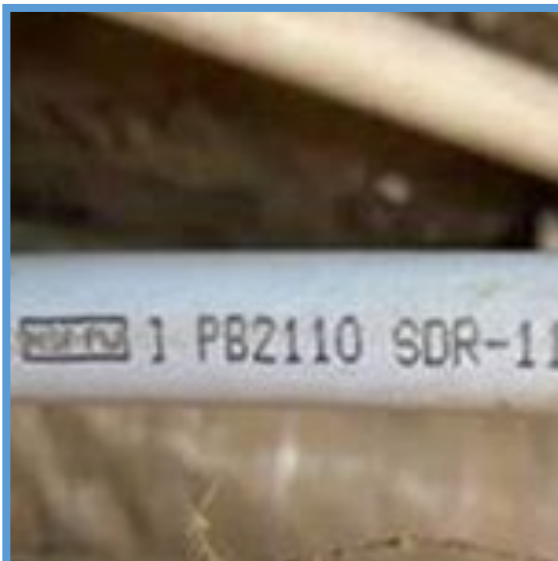
Grey Polybutylene pipe with PB2110 label

“PB” pipe is usually grey in color with a circular clamping ring at the fittings. Look for a stamp “PB2110” on the pipe. This stamp is the definitive identifier. PB will always have this stamp somewhere on the line.

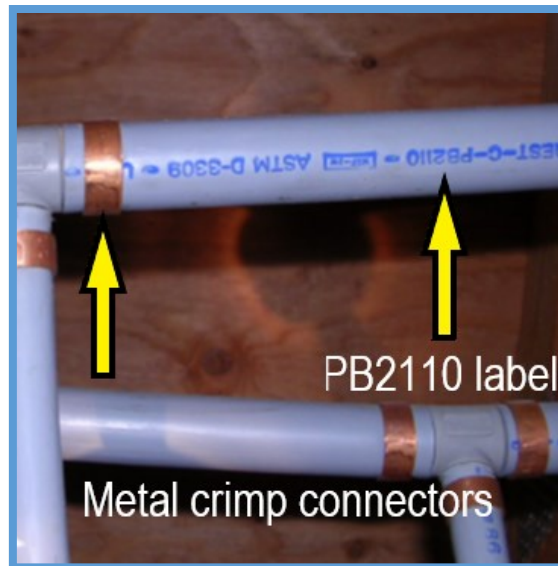
PB pipe with copper crimps

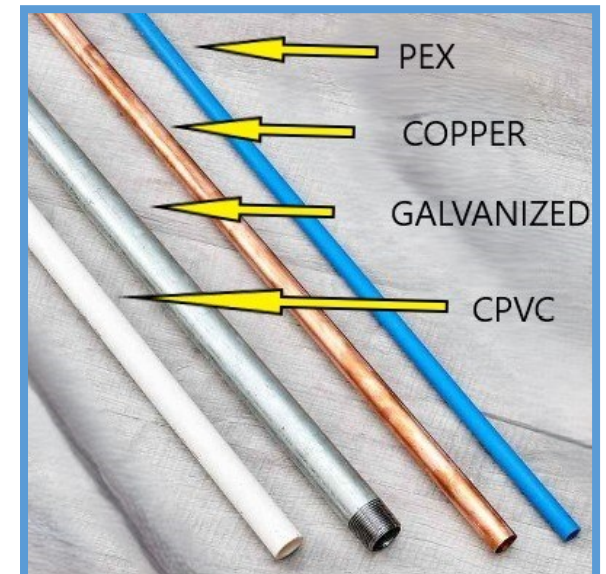
Different pipe types

The most common types of distribution lines found in homes are the familiar copper pipe, galvanized steel pipe, CPVC plastic pipe and newer PEX plastic pipe. Copper and galvanized are readily identifiable by their coloration, CPVC is ridged white plastic, whereas PEX, which comes in blue, red or white, will have the words “PEX” stamped on the lines.

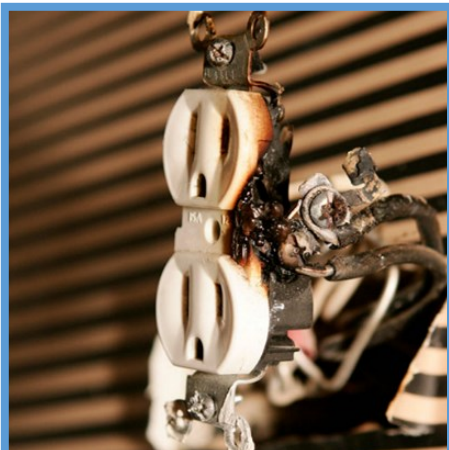
Outlet shorted out due to a failure of the aluminum to copper connection. As this connection failed, the aluminum wire became disconnected

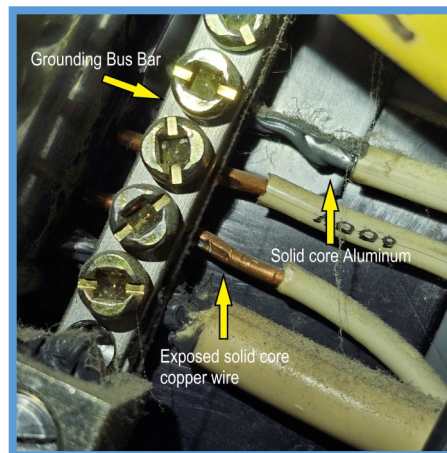
Inside an open service panel all the wire tips are exposed as they make their various connections. This is an easy way for a home inspector to identify alumi-

Unfortunately, aluminum wiring is not something diagnosed by a layman. The definitive diagnosis is having a home inspector remove the service panel's deadfront (not something an untrained person should do—it's called a "deadfront" for a reason). Inside the panel, the ends of the wiring are all exposed as they enter the various breakers or are attached to the neutral and ground bars. The wiring jackets are also readily readable inside the service box and will be stamped "AL". Important: not all aluminum or aluminum appearing wiring is at issue.

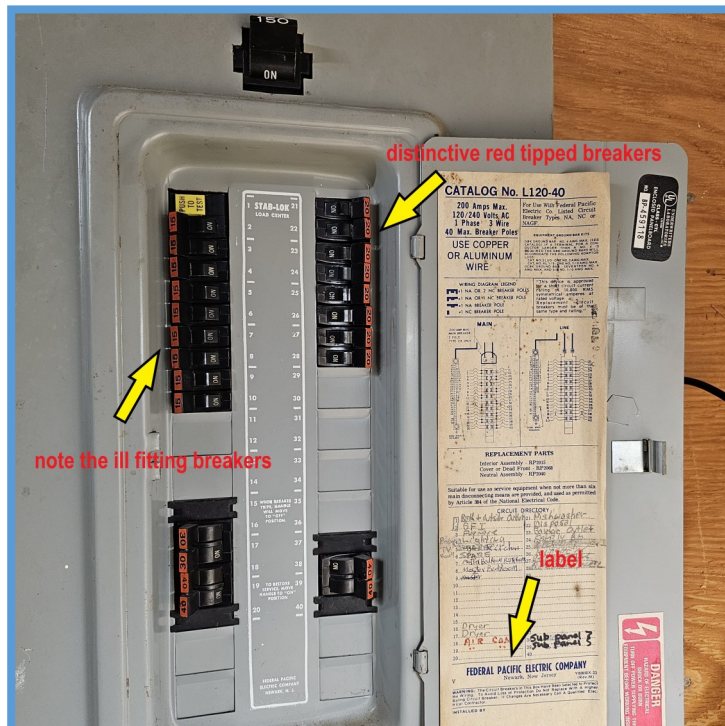
This is the only service box that has red tipped breakers

The issue with these panels, other than being obsolete and therefore cannot be repaired, is the breakers will not reliably trip when called upon to do so. The company was sued and promptly went out of business leaving behind thousands of these defective boxes installed. The lawsuit contended that during the testing of the circuit breakers, the Federal Pacific Company cheated in order to obtain the Underwrites Laboratories (UL) approval. Since this issue is well documented and the risks severe sometimes obtaining homeowners insurance can be challenging should the insurance company discover this type of service panel is installed.

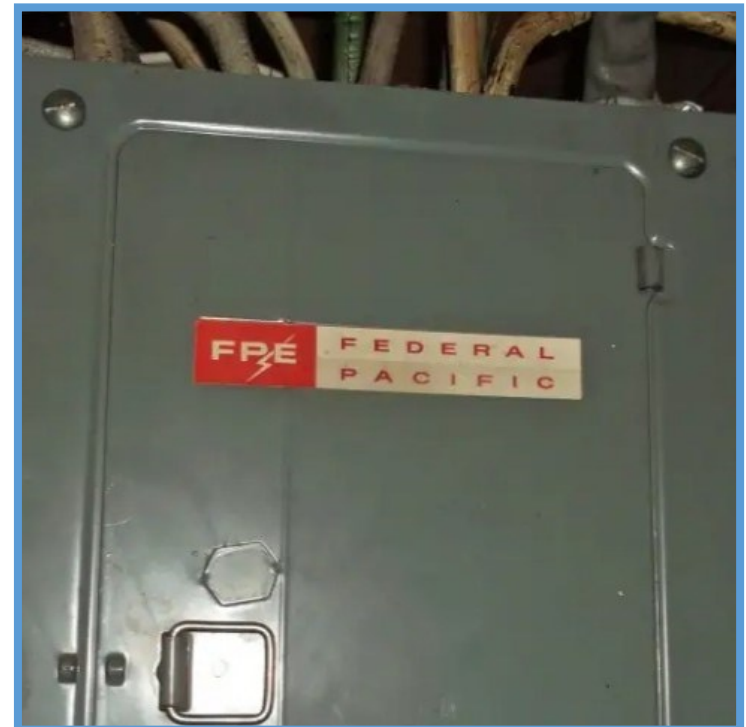
Distinctive Logo on the front

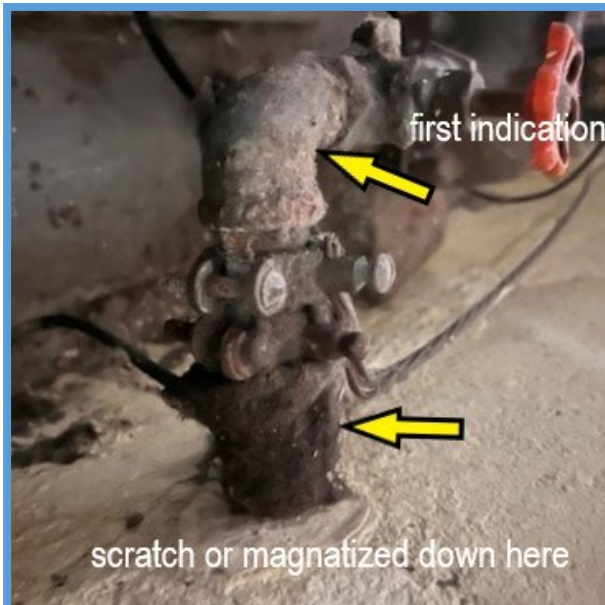
Look on the “Street” side of the water meter

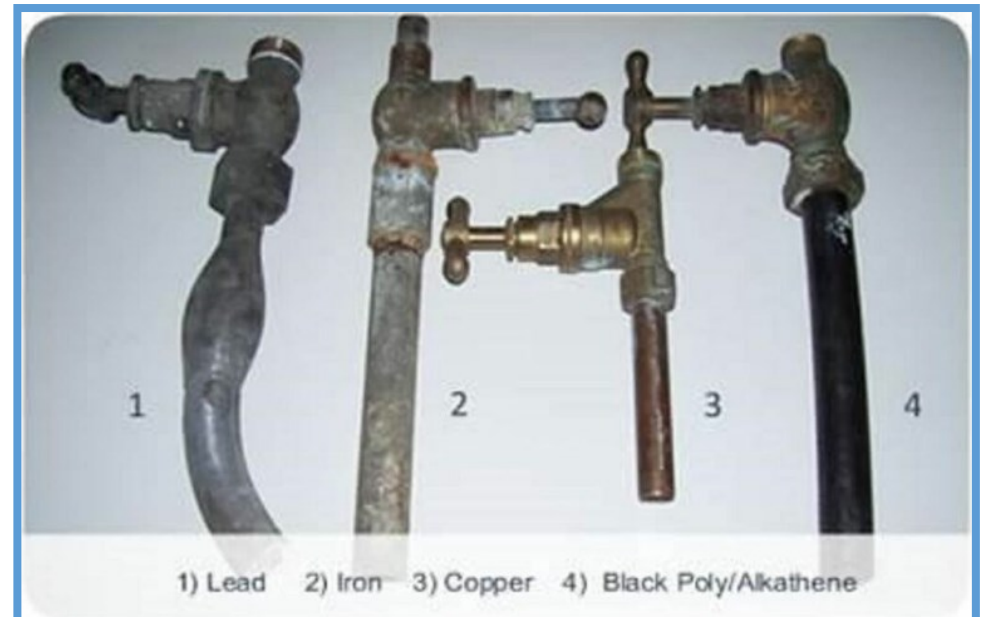
Different types of incoming water service lines

Fortunately galvanized steel is not too common. Most copper is pretty easy to identify. Scratch it; if it looks like a penny you have copper. Also copper fittings will be soldered or a “thread-less” compression fitting (like on example #3). #4 plastic is readily identified and #1 Lead we cover in another section. #2 is galvanized steel, and has threaded connections. It is also the only one that is magnetic. It is hard to scratch but will show the color of a nickel. Your first clue is the presence of a threaded elbow or coupling fitting.

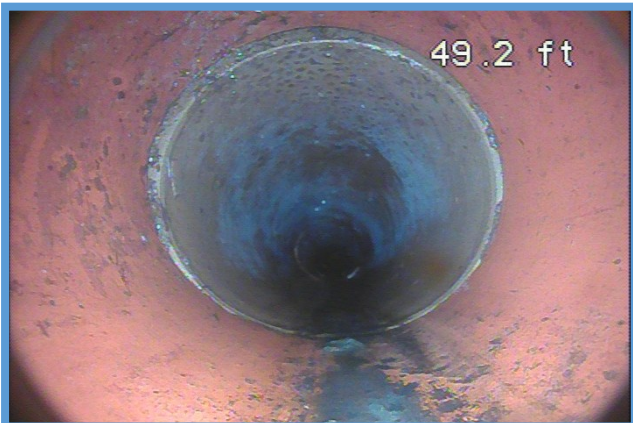
Clean, well sloped clay pipe. Note the obstruction free joint

Here are some typical still photos taken that would come with a video sewer examination and report.

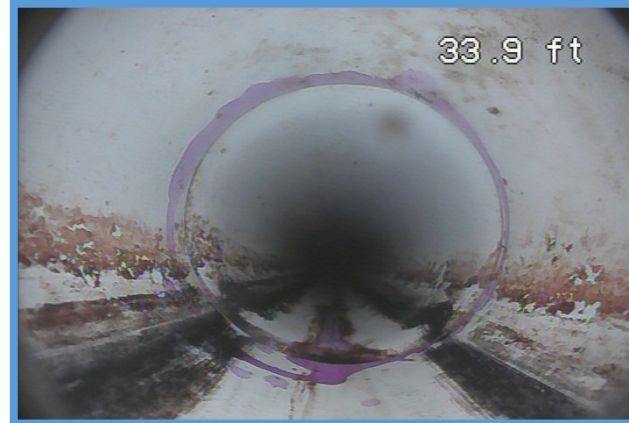
Clean PVC plastic pipe. Note the purple primer an indicator of a properly constructed PVC joint

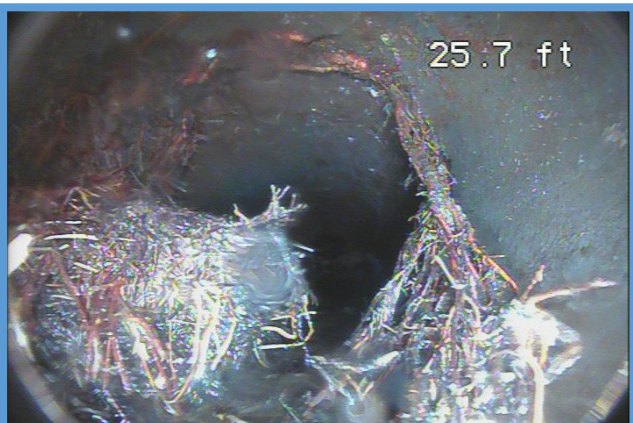
Clay pipe with root mass partially blocking the pipe

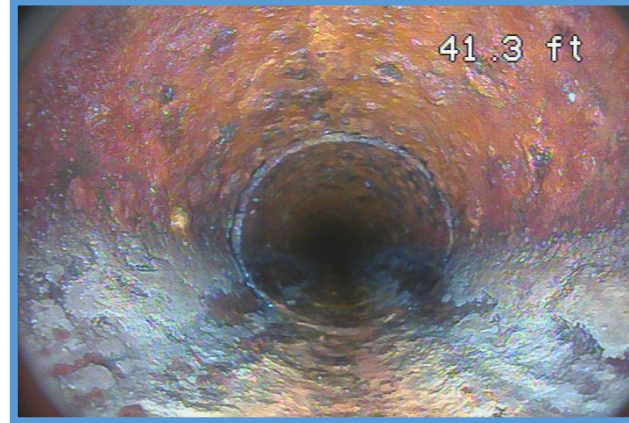
Clean and well sloped cast Iron pipe. Note the joint here is welded with a mixture of oakum (a fiber material) and sealed with liquid lead

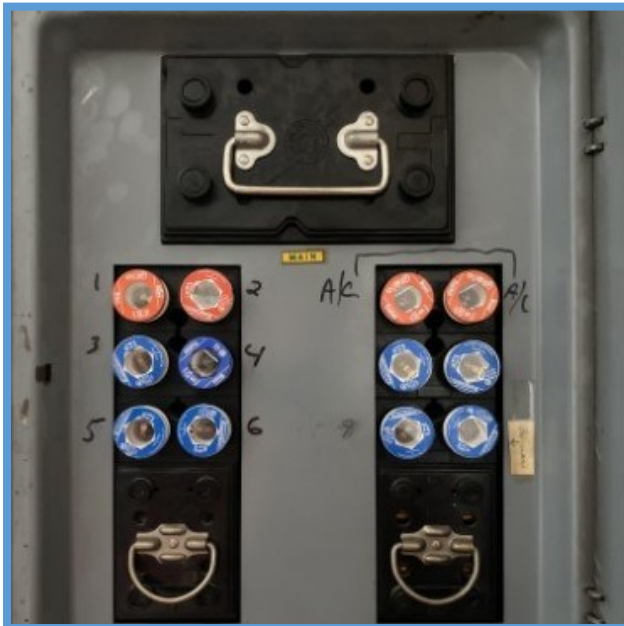
Example of a fuse panel. The orange fuses are 20 amp and the blue are 15 amp fuses. 220v fuses for, say a dryer, are below in the "pull outs"

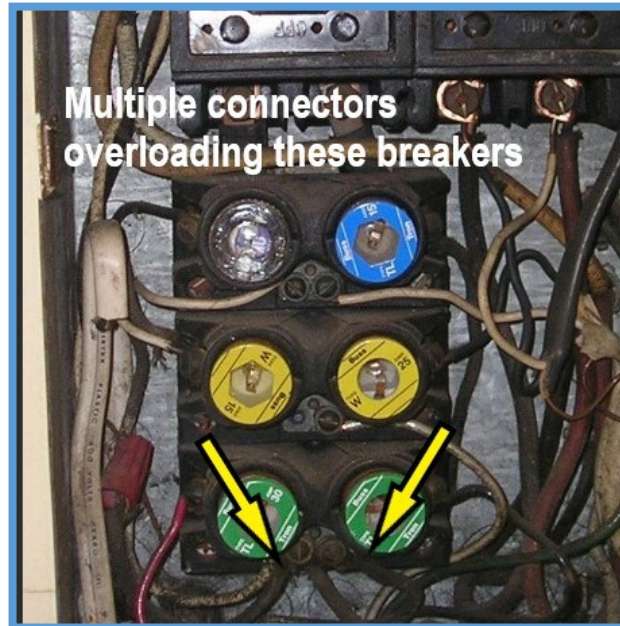
Example of an overloaded fuse box. Note multiple conductors attached to the fuses.

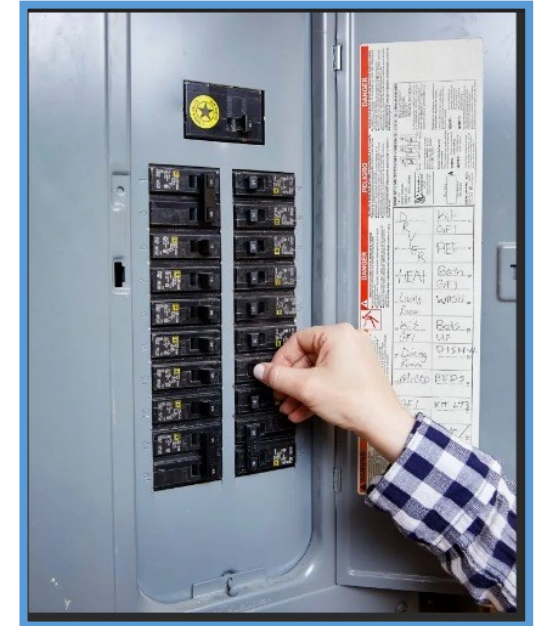
Example of a modern circuit breaker panel. Simply reset a breaker if it trips.

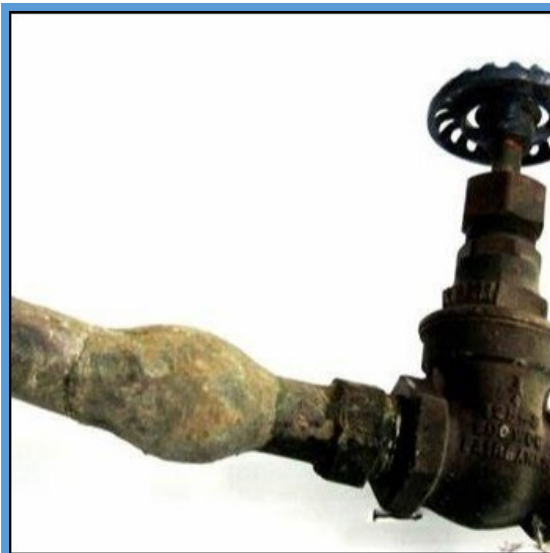
Distinctive swollen lead connector

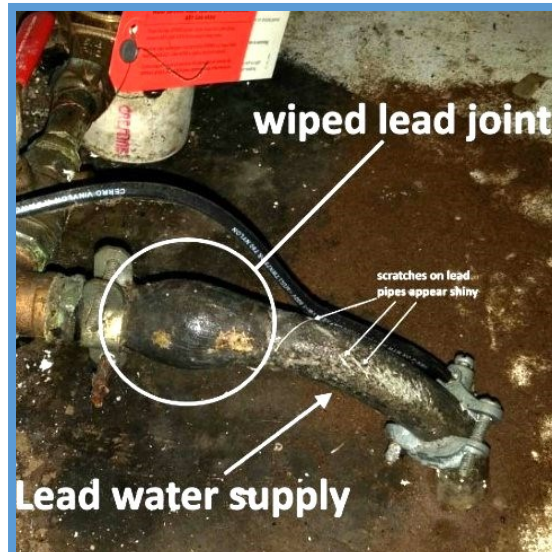
Lead service line right before the water meter

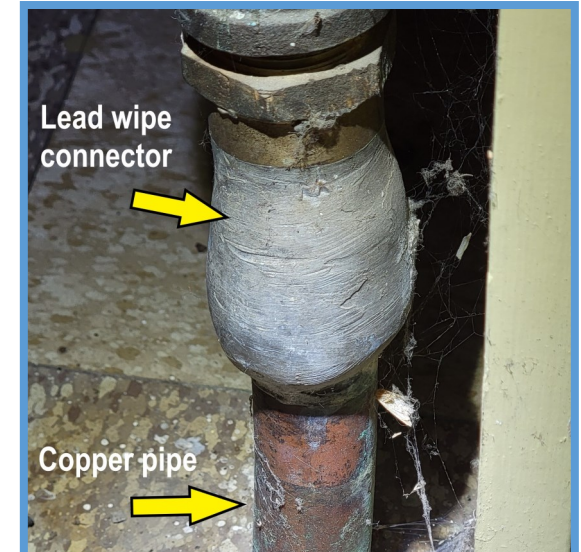
Lead connector on new copper water line

Oddly enough, that when some lead lines are replaced with copper service lines this lead connector is left intact. I have contacted SPRWS and haven’t received an answer as to why this portion of the lead line is left intact. I can only surmise that its effects are minimal.
